Optimization of Three-Dimensional (3D) Multi-Sensor Models For Damage Assessment in Emergency Context: Rapid Mapping Experiences in the 2016 Italian Earthquake

Giulia Sammartano

Politecnico di Torino, Department of Architecture and Design, Torino, Italy;
giulia.sammartano@polito.it

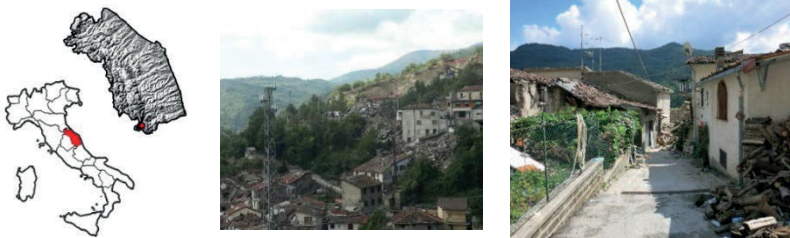
Figure 3. Pescara del Tronto in Arquata del Tronto municipality (Ascoli Piceno), is one of the perched villages allocated across the Apennines mountain in Marche region (left, center), center Italy, on the border with regions Abruzzo, Lazio, Umbria. It was destroyed by the reiterated seismic shocks from

The present contribution is focused on the ancient perched village of Pescara del Tronto (Figure 3), in Arquata del Tronto municipality. The techniques that were deployed by the teams have been focused on the documentation post-disaster of the whole village with multi-scale approach and resulting assorted multi-sensor acquisitions. Groups of differently damaged buildings were examined, with the combined use of terrestrial and aerial sensors.

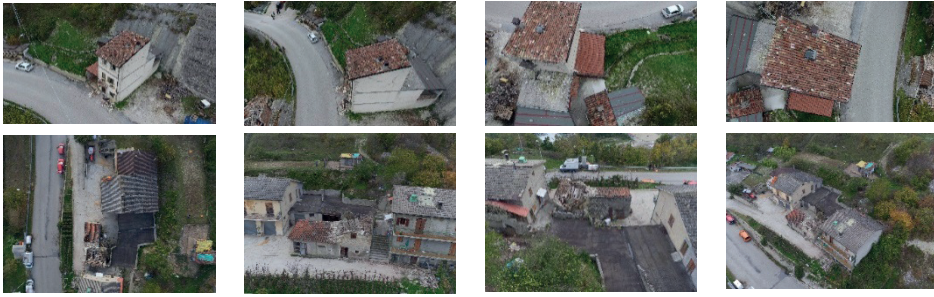
Figure 7. Samples datasets of acquired images by flights. North area, Phantom4 (first row) and South area, Inspire1 (second row).

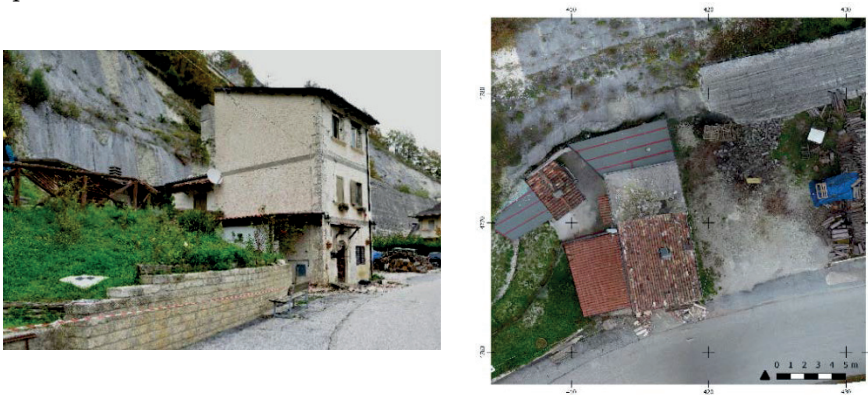
Figure 14. An images of the building n°5 in October 2016 and relative orthoimage by multi-rotor drone (aerial images of both shooting and frames extraction from 4k video with DJI drone).

A pertinence area around the test building have been chosen too (Figure 14). A large amount of information have been extracted from aerial and terrestrial acquisition and classified from images and 2D/3D production, as in following examples.

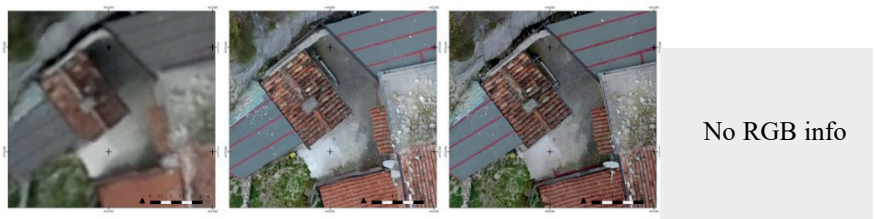
Figure 16a. Comparison, on a small area, between used platforms and sensors: eBee, average GSD of 5 cm/pixel (left); DJI Phantom, average GSD of 2.18 cm/pixel (center left); fusion model, average GSD of 0.92 cm/pixel (center right); no RGB data from Zeb1.

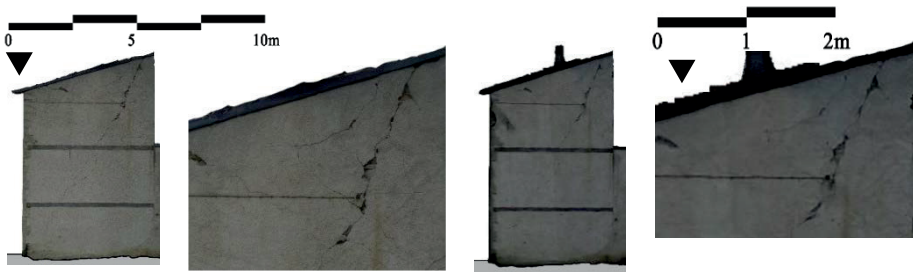
Figure 17. Orthoimage of the East side. The aerial model by integrated oblique and nadir cameras (right), can be comparable in terms of available detail and the accessible information to the terrestrial photogrammetric one (left).

A photogrammetric model by commercial DJI drone, as in Orthoimage, is highly competitive in terms of quality of RGB information. The standard of comparison is a well-known terrestrial close-range photogrammetry, a solution that is less viable in these contexts of timing and accessibility to spaces. Most damages and creeps on all of the façades are clearly visible even in the aerial model (as in example in Figure 17), better than in the fusion one. More reflections
